TSB # 323-0035
Prince Castle
355 East Kehoe Blvd
Carol Stream, IL 60188
04/05/2017

In a going effort to ensure quality on our Genuine OEM Equipment we are Issuing a TSB for our DCFT-MCD toasters Series. This TSB removes a heat shield bracket (OEM Part # 527-815) that can potentially cause pre-mature wear of the club section drive gear. In addition to the wear, when this bracket comes in contact with the gear it makes a high pitch squeaking noise. Please see information below on how to correct this issue.

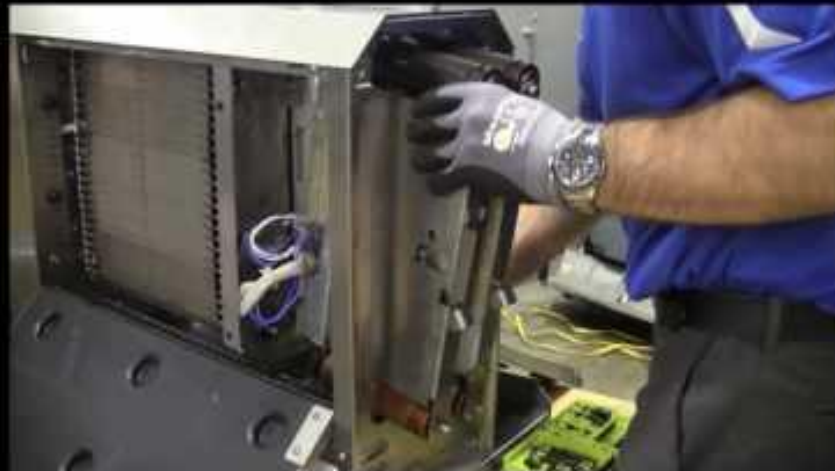
Pull Out Club Section Slightly
