TSB # 323-0053
Prince Castle
355 East Kehoe Blvd
Carol Stream, IL 60188
Date 10/30/2017

In a going effort to ensure quality on our Genuine OEM Equipment we are Issuing a Technical Service Bulletin for our DCFT Toaster Series. This TSB depicts how to correct reverse compression issues. Please Read Detailed information below.

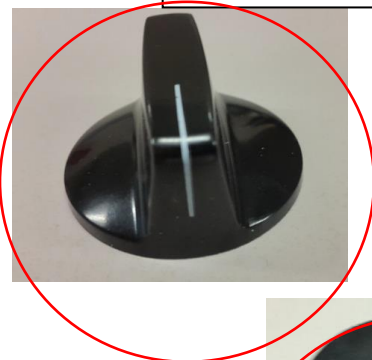
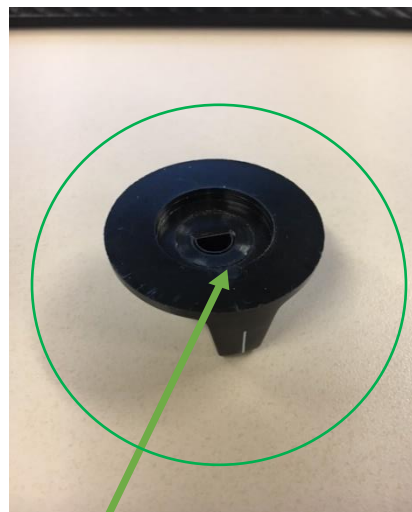
Old OEM Knob Part # 526-756

Compression settings are opposite of the original OEM setting due to the knob indicator mark and D slot being reversed. Early Generation Knobs (OEM Part # 526-221) are not affected.

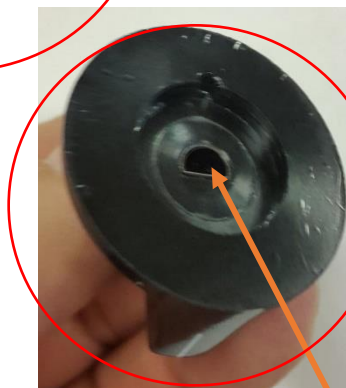
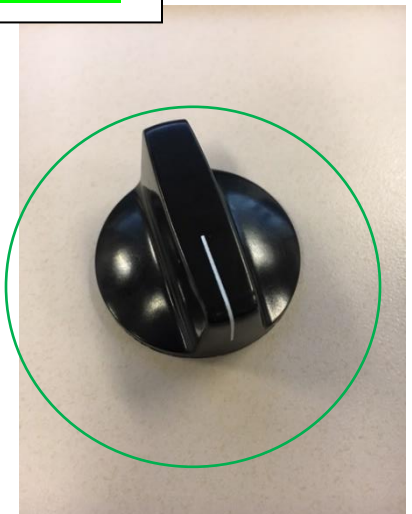
New OEM Knob Part # 526-757

Locator flats 180 deg. across to each other
