TSB # 323-0059  
Prince Castle  
355 East Kehoe Blvd  
Carol Stream, IL 60188  
Date 1/22/2018

In a going effort to ensure quality on our Genuine OEM Equipment we are Issuing a Technical Service Bulletin for our DCFT Toaster Series. This bulletin will cover the retrofit of the new DCFT Club Idler Pulley Assembly (OEM Part # 527-888s) that will be replacing discontinued Pulley Assembly (OEM Part # 527-818s) listed below. Please see detailed instructions below.

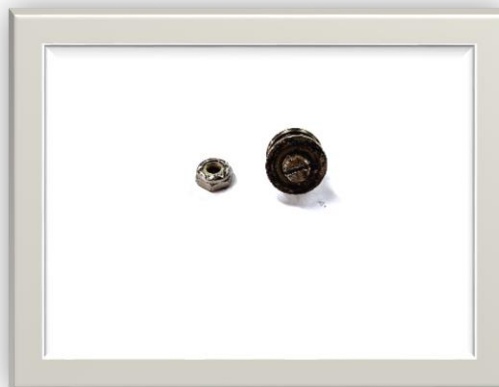
- 527-818s (Club Driver Idler Pulley – Assembly)

Old rev Idler Pulleys could have reduced life span causing damage to the club drive belt. This could lead to the club section unable to rotate.
