TSB # 323-0037
Prince Castle
355 East Kehoe Blvd
Carol Stream, IL 60188
Date 4/17/2017

In a going effort to ensure quality on our Genuine OEM Equipment we are Issuing a TSB for our CBT toasters Series. We have discovered that stores are not taking proper cleaning procedures with the landing zone. This new kit (OEM Kit Part # 95-1945s) allows the landing zone to be locked down with Pre-Loctited screws to prevent ripping of the landing zone cord. **Please note this is not covered under Warranty.**

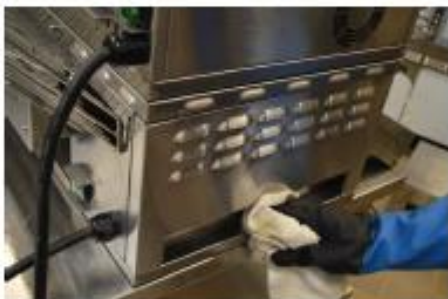
1

Remove crumbs from the crumb collection portal by wiping with a clean, sanitizer-soaked towel. Then, clean the crumb collection portal with a clean, sanitizer-soaked towel sprayed with Heavy Duty Degreaser solution. Rinse with a separate, clean, sanitizer-soaked towel.

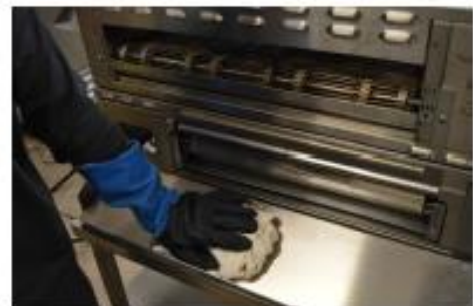
4

Wipe out landing zone tray with a clean, sanitizer-soaked towel sprayed with Heavy Duty Degreaser solution. Rinse with a separate, clean sanitizer-soaked towel.

- Install new landing zone kit with Pre-Loctited screws (OEM Kit # 95-1945s)
- Follow Daily Cleaning instructions step #4 in the Operations Manual Included with the toaster. If the manual has been misplaced please scan QR code below.

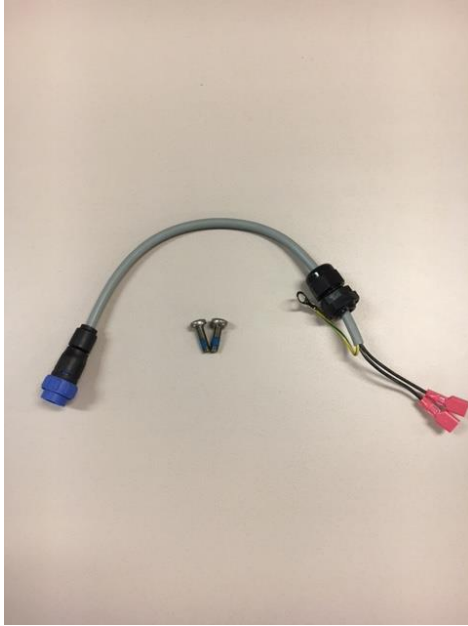
95-1945s Remove and Install

- Landing zone will not heat up to OEM specified temperature
- Landing zone cord is damaged
- Male and Female connection cord ends are damaged
